Answers in Geomorphology and Land Use Planning

Attached is the draft report on geomorphology of the Hazel and Gold Basin landslides. Please review it and call me with any questions and comments. I am also sending a copy to Tracy Drury and to Bob King at HDR Engineering.

Site Descriptions

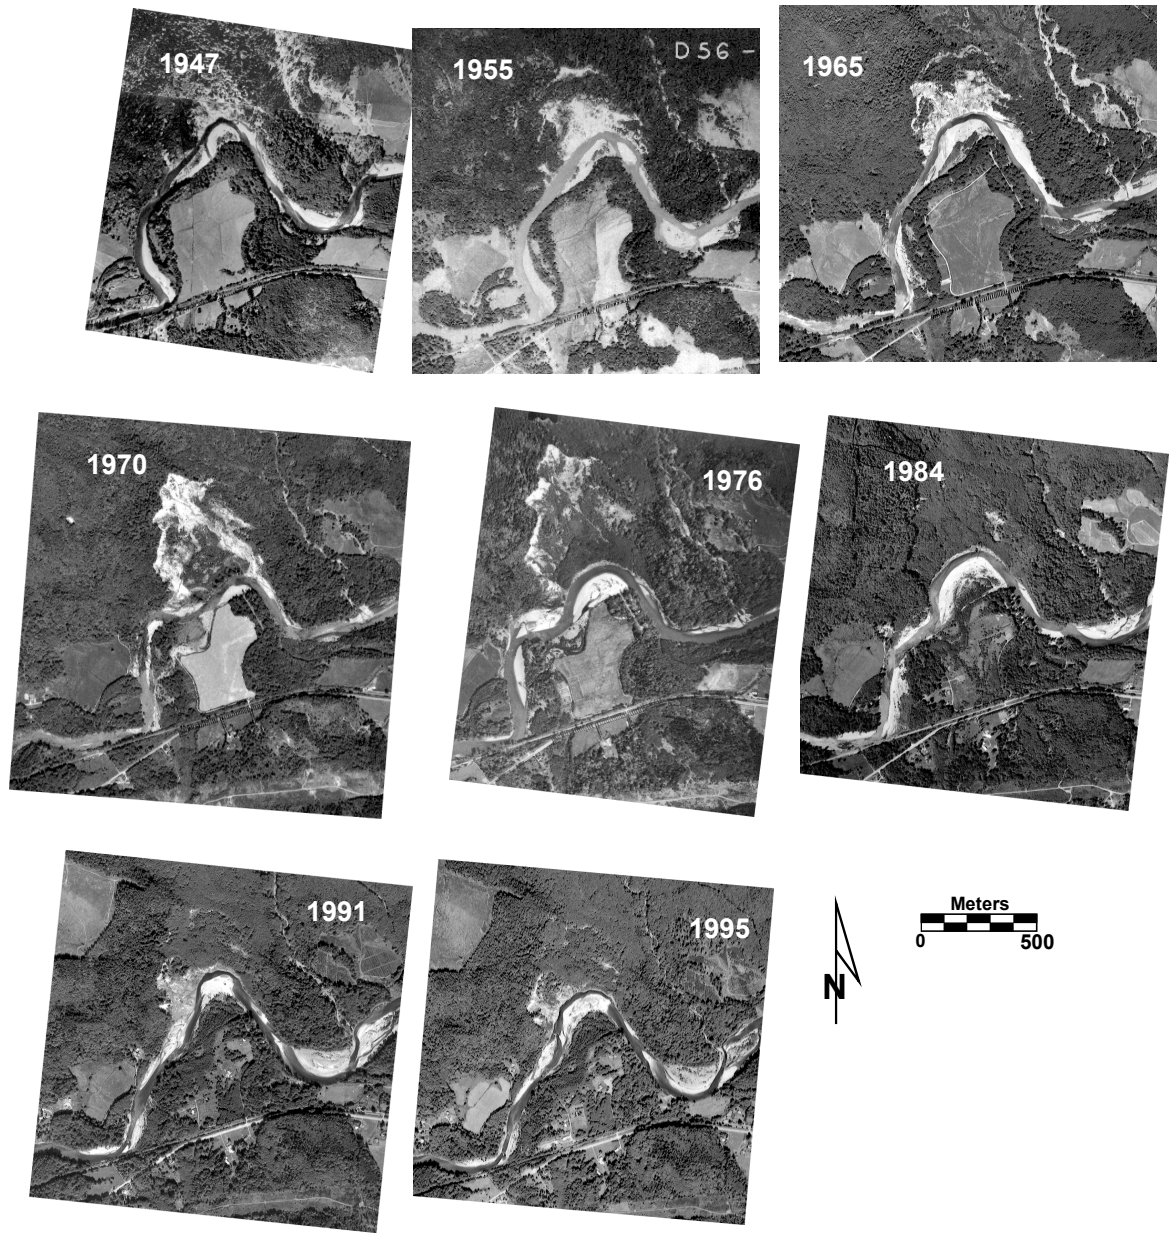
Figure 2. Aerial photograph record for Hazel landslide.
Major events occurred in 1951, 1967, and 1988.

Benda et al. (1988) estimated a landslide size of approximately 10 acres from 1942 photographs. Tracings made by Curtis (1988) show relatively little activity at that time. The landslide appears relatively quiescent in 1947 photographs (Figure 2). In 1951, however, a mud flow from one of the channels draining the landslide briefly blocked the river. In 1952, Shannon and Associates reported activity extending up to 1000 feet from the river's edge, with headscarps 70 feet high and downslope motion of large, intact blocks. They also reported persistent turbidity from channels draining the landslide. The photographs shown in Figure 2 indicate that landslide activity persisted over the next decade, with the river at the toe throughout this period. A berm of alluvium and logs was constructed in the summer of 1960 in an attempt to protect the toe of the landslide. It was eroded away the first winter (Webb and Rees, 1961). A rock revetment was constructed along the eastern portion of the slide toe in 1962, which persists to this day.

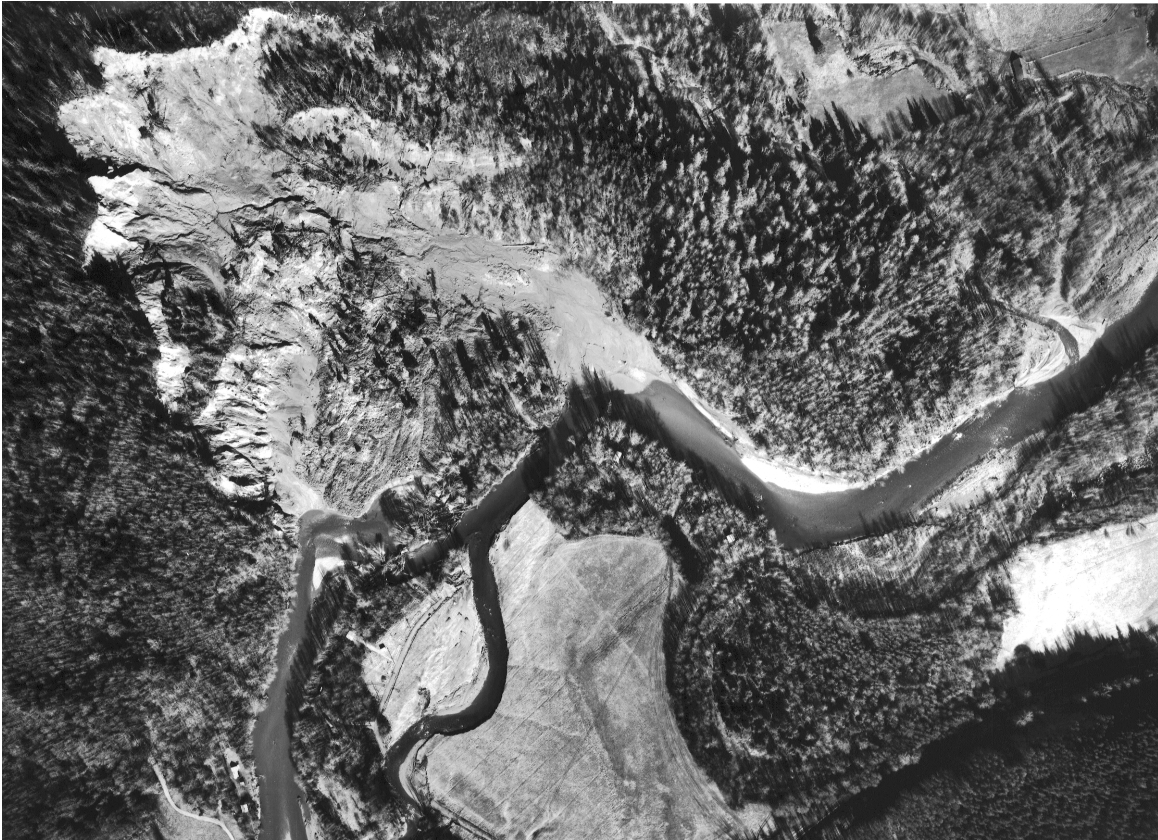
Figure 3. View of the Hazel landslide in 1967, within weeks after the January event.

Despite protection of the toe by the revetment, a large event occurred in January 1967, which dramatically altered the geometry of the landslide and the river channel (Figure 3). Downslope translation of a large block and accompanying mud flows pushed the river channel about 700 hundred feet to the south. Debris from this event then insulated the landslide toe from further bank erosion. Over the next 20 years, gradual revegetation of the landslide scar marks a period of

The most direct effect on the mainstem has been blocking and diversion of the channel by landslide debris. The January 1967 event displaced the channel about 800 feet southward and caused avulsion of a side channel (see the photographs in Figures 2 and 3). Later photographs show no obvious up- or downstream consequences of this diversion. The greatest subsequent change is gradually northward migration of the channel through the deposited debris, back towards its former channel, and abandonment of the side channel after several years.

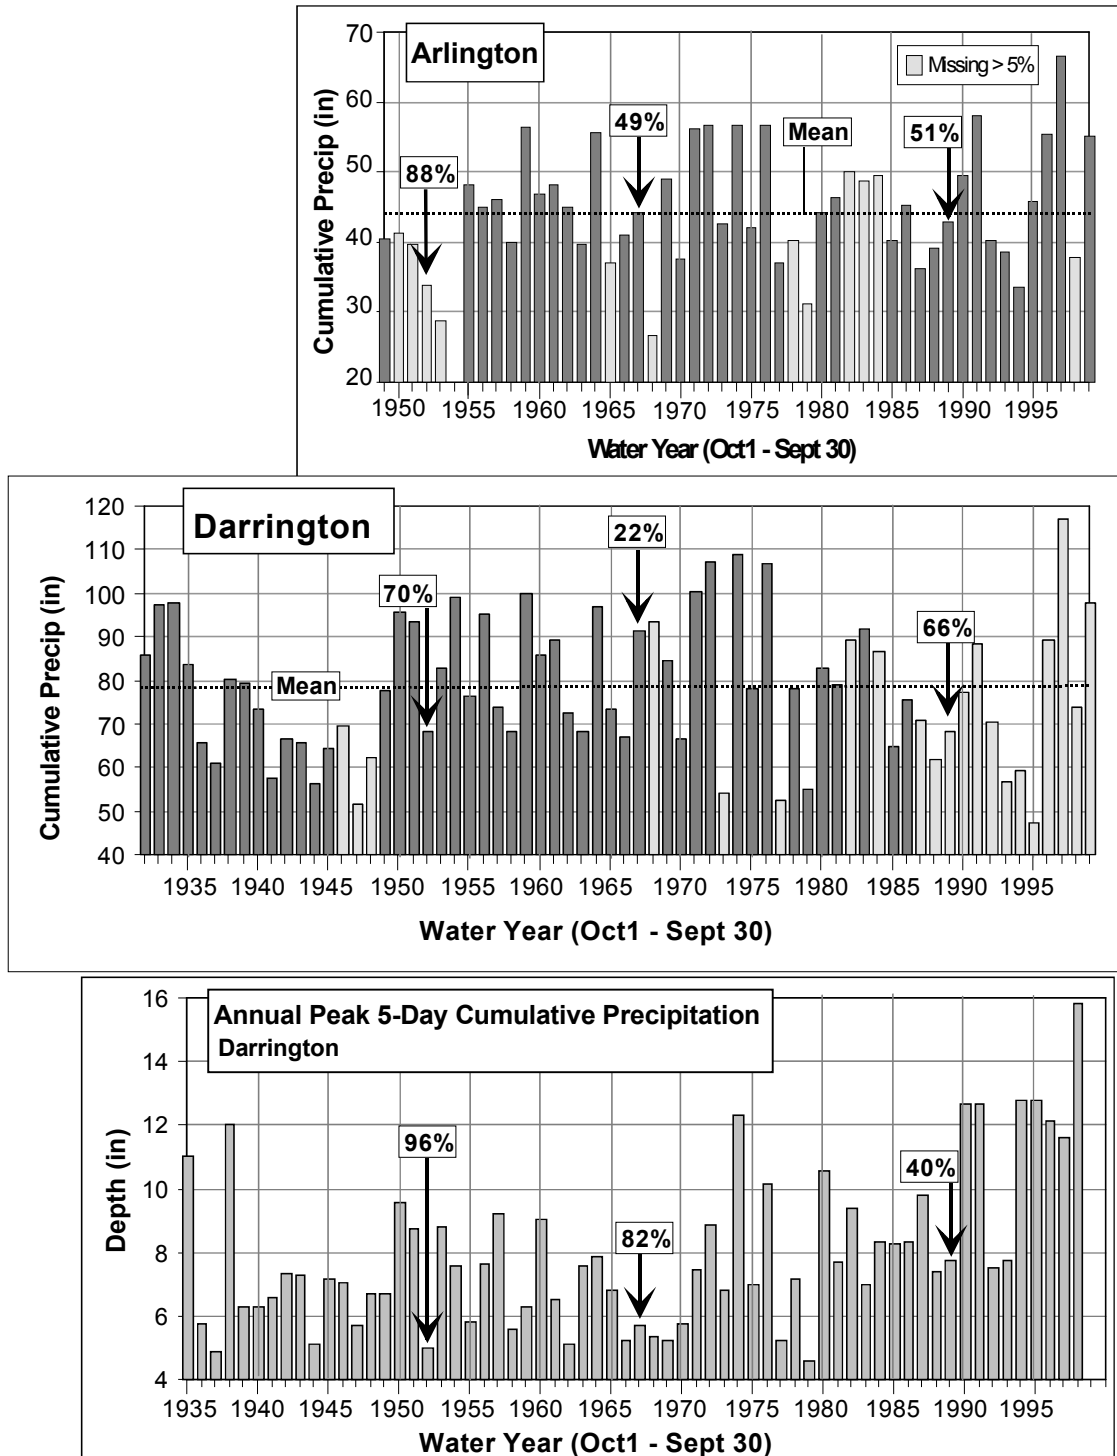
Figure 4. Summary climate data.

Data are taken from weather stations at Arlington and at Darrington. The upper two graphs show cumulative annual precipitation for both gages. Years missing values for more than 5% of the days over the period October to June are indicated with light shading. Timing of the three largest events on Hazel are shown with arrows. Numbers above the arrows indicate proportion of years having greater cumulative precipitation. The lower graph shows peak annual 5-day cumulative totals. This provides a measure of storm intensity that includes antecedent moisture.

Figure 4 shows summary climate data from weather stations at Arlington and Darrington. Hazel falls about midway between these two stations. The upper two graphs show cumulative annual precipitation depths, integrated over the water year (October 1 of the previous year through September 30). Total precipitation is greater at Darrington, but year to year variability tends to correlate between the two sites, i.e., wet years at Arlington are also wet years at Darrington. Arrows indicate the timing of the three major, river-blocking events on the Hazel slide, those in December 1951 (water year 1952), January 1967, and November 1988 (water year 1989). Numbers above the arrows indicate the percentage of the years of record having cumulative precipitation greater than that year. These graphs show no clear connection between cumulative annual precipitation and the occurrence of major events.

It is also possible that individual storm events are triggering landslide activity. The bottom graph shows the peak annual 5-day accumulated rainfall depth at the Darrington station. Although major events are associated with the largest storms of the year, they are not occurring in the years with the largest storms. These observations reveal no clear connection between temporal patterns of precipitation and landslide activity.

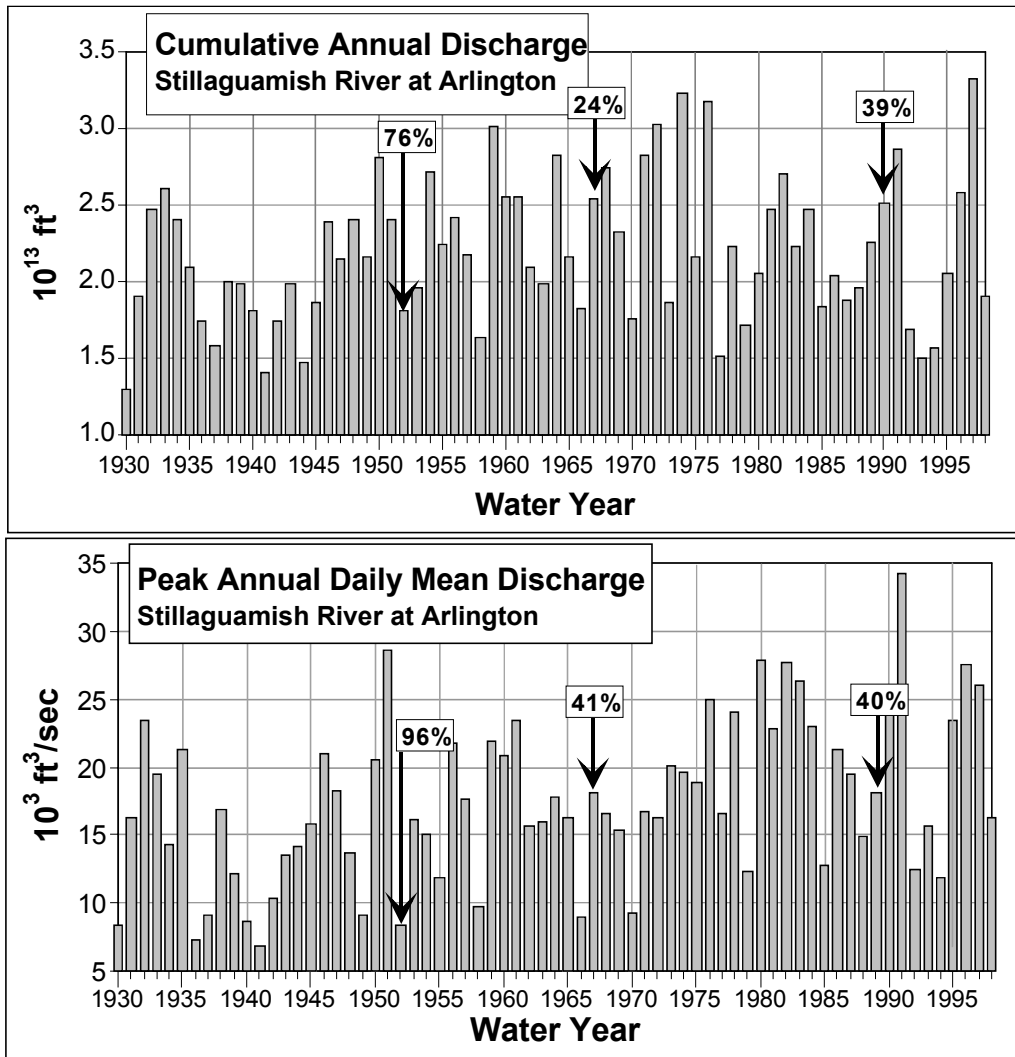
Figure 5. Summary discharge data for the North Fork Stillaguamish.

These data are taken from the gage near Arlington, which has the longest continuous record. The upper graph shows cumulative annual discharge, the lower graph shows annual peaks. Again, the timing of major events at Hazel are indicated with arrows. The numbers above the arrows indicate the proportion of years having larger cumulative or peak values.

We can also look for relationships between discharge in the Stillaguamish and activity on the landslide. Figure 5 shows both cumulative and peak annual discharge at the gage on the North Fork near Arlington. This is the only gage in the basin with a long, continuous record. I plot cumulative discharge as a measure of total transport potential. Since sediments composing the landslide are predominately fine grained, even relatively small flows may move material delivered to the channel. Peak annual discharge provides a relative measure of the erosive potential of individual flood events. Again, although the largest landslide events tend to occur during high water, coincident with large storms of course, there is no clear relationship between the largest events and initiation of landslide activity.
